# **Debris/Ice/TPS Assessment and Integrated Photographic Analysis of Shuttle Mission STS-94**

*Process Engineering/Mechanical System Division/ET-SRB Branch,  
Kennedy Space Center, Florida*

**DEBRIS/ICE/TPS ASSESSMENT  
AND  
INTEGRATED PHOTOGRAPHIC ANALYSIS  
OF  
SHUTTLE MISSION STS-94**

**1 July 1997**

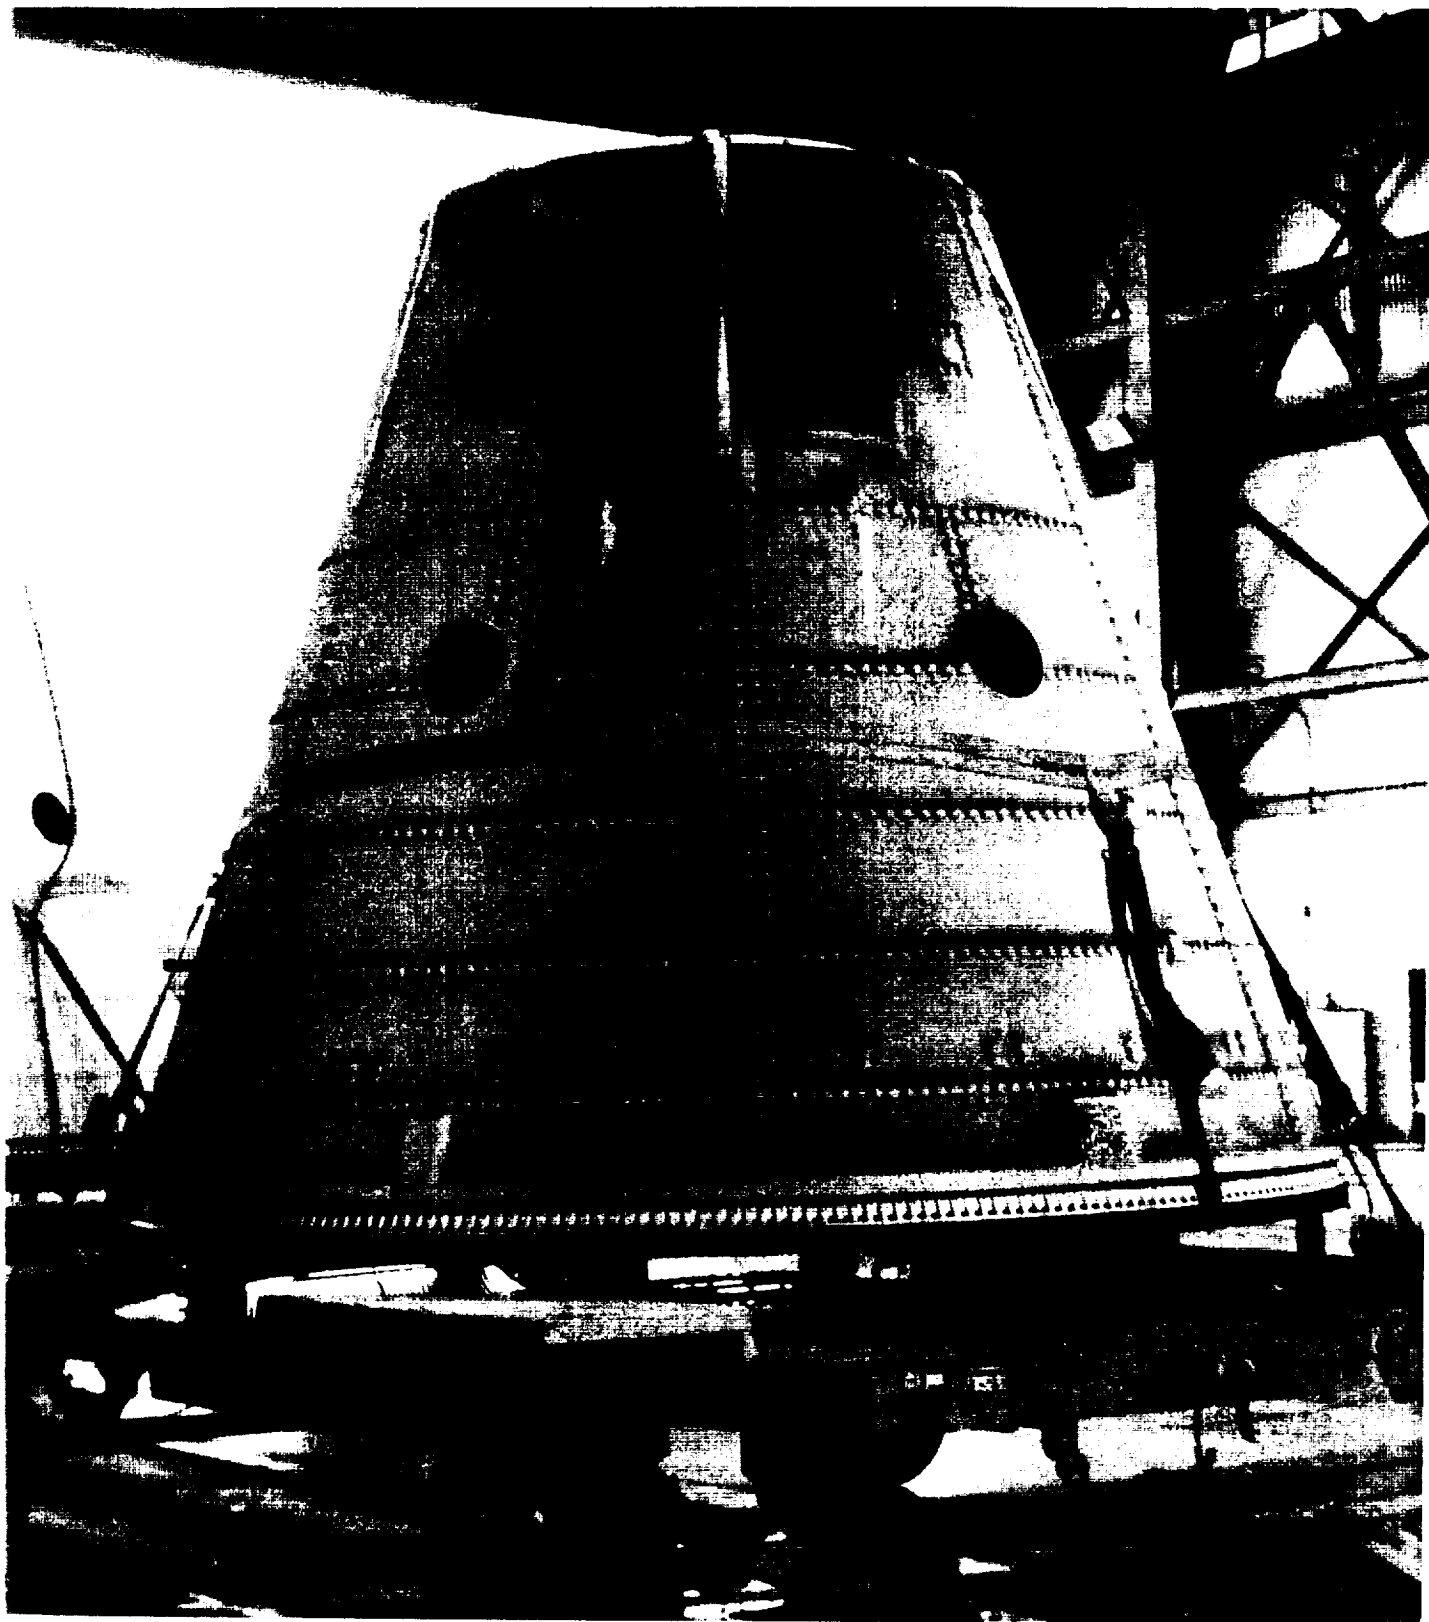
Photo 15: Right Frustum

The Solid Rocket Boosters were inspected at Hanger AF after retrieval. Both frustums were in excellent condition. No TPS was missing and no debonds were detected over fasteners. All four Booster Separation Motor (BSM) aero heat shield covers on the right frustum were locked in the fully opened position. The lower right BSM aero heat shield cover on the left frustum was locked in the fully opened position; the remaining covers were bent. The BSM aero heat shield cover attach rings had been bent by parachute riser entanglement after splashdown. The forward skirts exhibited no debonds or missing TPS. The Field Joint Protection System (FJPS) closeouts were generally in good condition. Trailing edge damage to the FJPS and the GEI cork runs were attributed to debris resulting from severance of the nozzle extension. One area of forward edge damage was noted on the right hand center joint at about the 200 degree position. This damage was most probably caused by ice from the ET LO2 feedline forward bellows. Seven of the holddown post Debris Containment Systems (DCS) plungers were seated and appeared to have

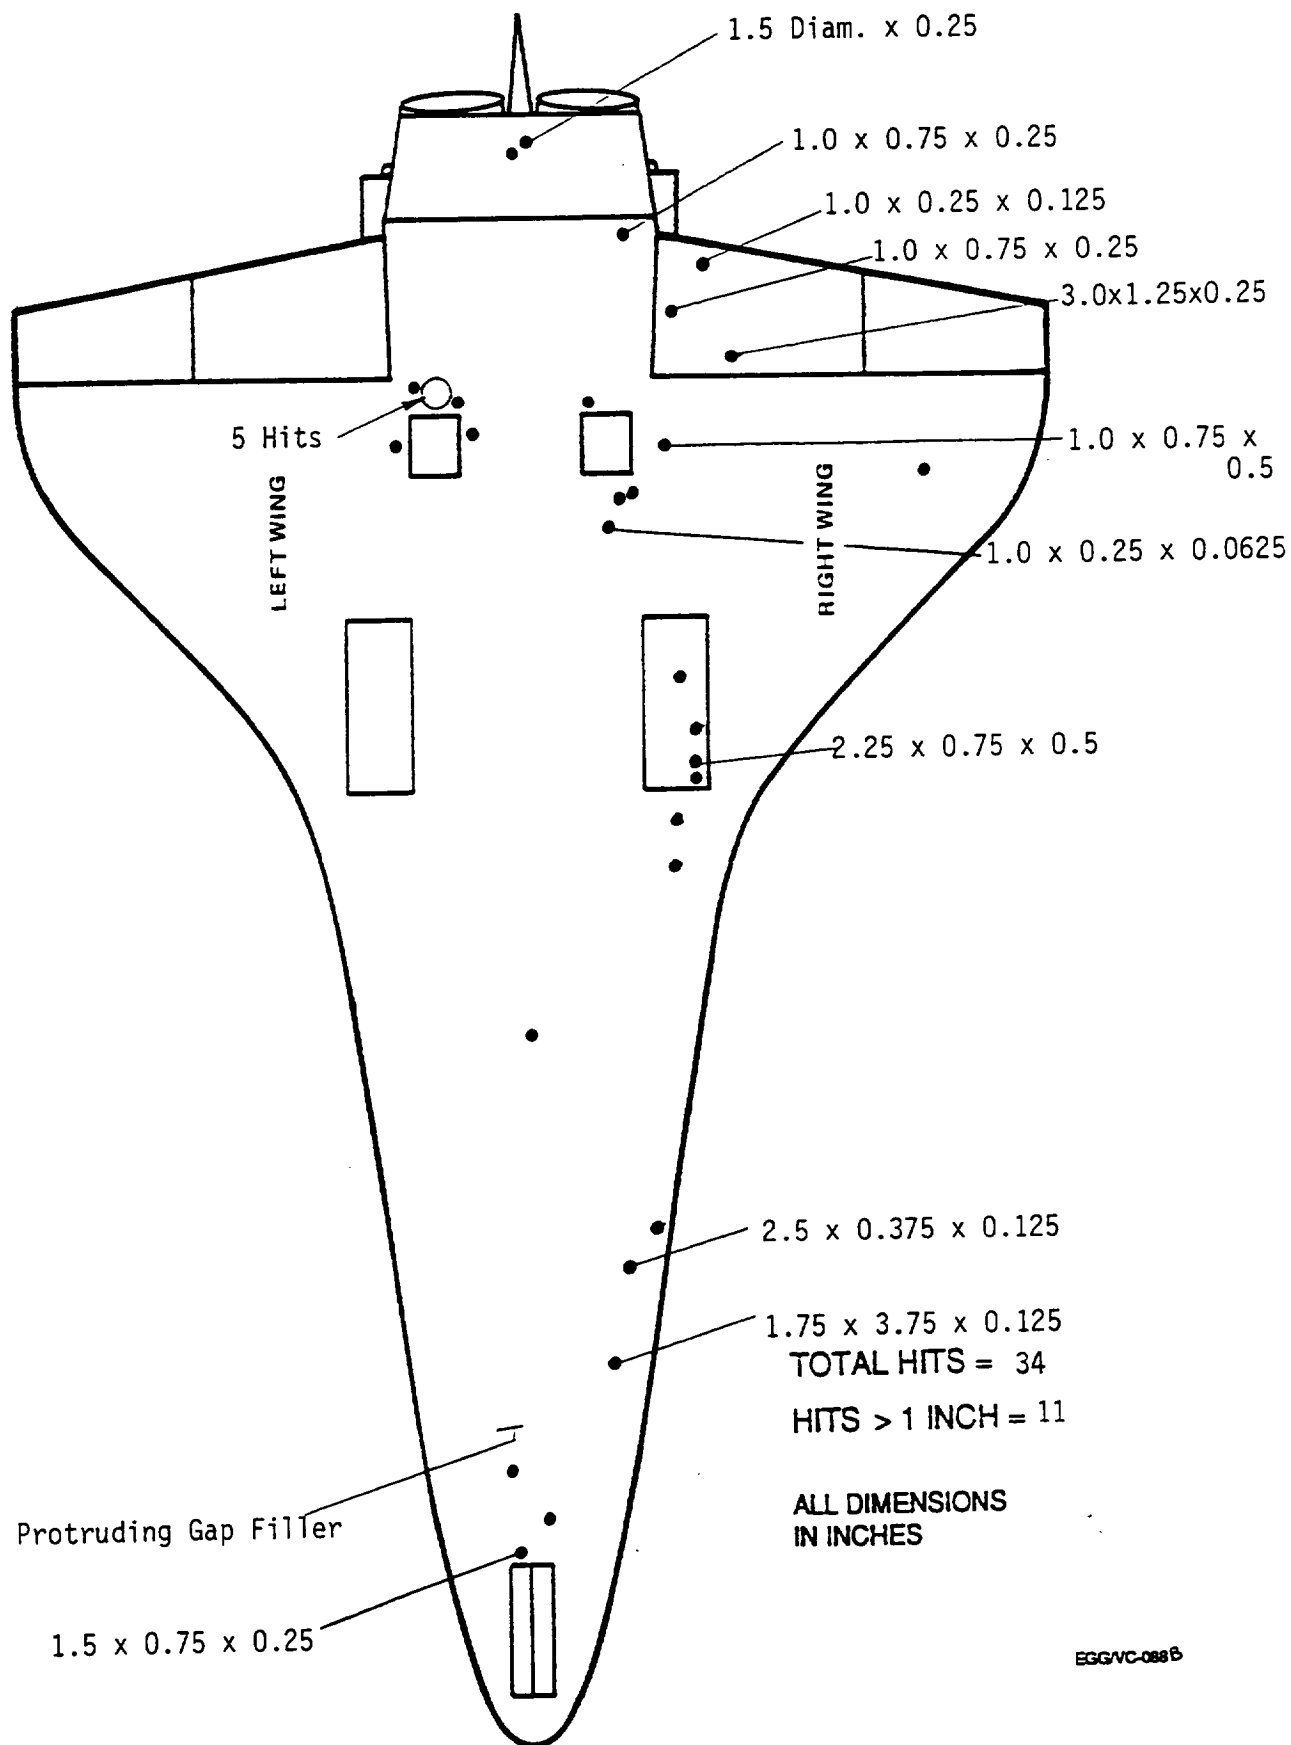
**Figure 1: Orbiter Lower Surface Debris Damage Map**

The Orbiter lower surface sustained a total of 34 hits, of which 11 had a major dimension of 1-inch or larger. The largest lower surface tile damage site was located on the right chine. The site measured 3.75 inches long by 1.75-inches wide by 0.125-inches deep.

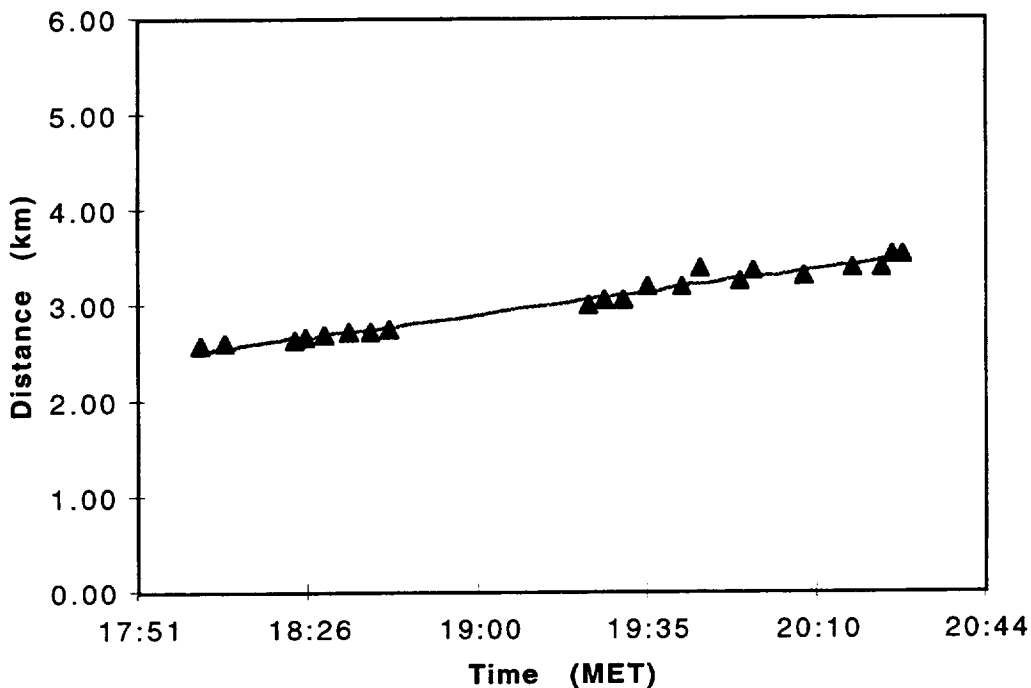
Figure 2.5.2 (B) ET Separation Velocity

The distance of the external tank was calculated on twenty frames. On the first usable view, the external tank was calculated to be at a distance of 2.6 kilometers away from the Orbiter at 18:04 MET. On the last view, 2 minutes and 23 seconds after the first view, the tank was calculated to be at a distance of 3.5 kilometers (18:06:23 MET). The tank separation average velocity was determined to be 6.6 meters/second (m/s), with an uncertainty of approximately 1 m/s. The tank tumble rate was approximately 1.8 degrees/second. The tank roll rate was 0.3 degrees/second.

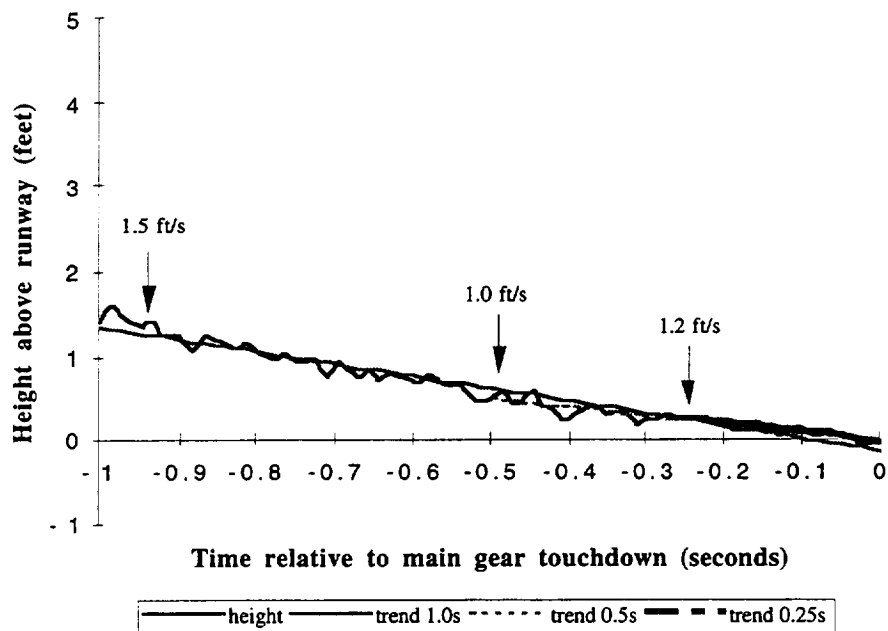
Figure 2.6.1 (A) Main Gear Height versus Time Prior to Touchdown

The measured main gear sink rate values were found to be below the maximum allowable values of 9.6 ft/sec for a 211,000 lb. vehicle and 6.0 ft/sec for a 240,000 lb. vehicle. The landing weight of the STS-94 Orbiter was reported to be 230,911 lb. The sink rate measurements for STS-94 are given in Table 2.6.1. In Figure 2.6.1(A), and 2.6.1(B), the trends of the measured data points for the image data are illustrated.
